Changes in Operating Practice for Increasing the Life of Pots in ALRO SLATINA

**Gheorghe Dobra,
Marin Cilianu and Gilbert Ciobanu***
*VIMETCO ALRO
116 Pitesti Str., Slatina, 230048, Romania*

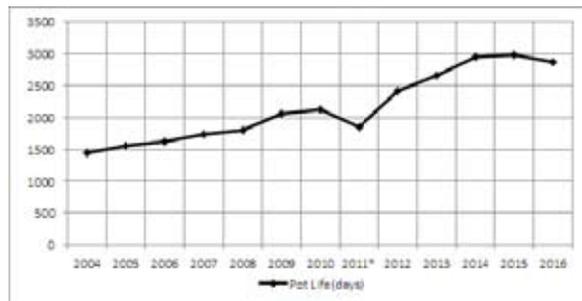
Fig. 2. Pot Life evolution

Implementation of the above measures during 2004 – 2016 led to the increase of potlife from 1440 days to 2860 days, as shown in Fig. 2.

The average life of pots stopped in 2011 is influenced by the average lifespan of pots in operation from Potroom no. 10, which was shutdown in 2011 for economic reasons.

In year 2016 the decrease of the average lifespan is mainly due to the shutdown of some pots in Potroom no. 9 which had been started-up with the recovered cathodes.

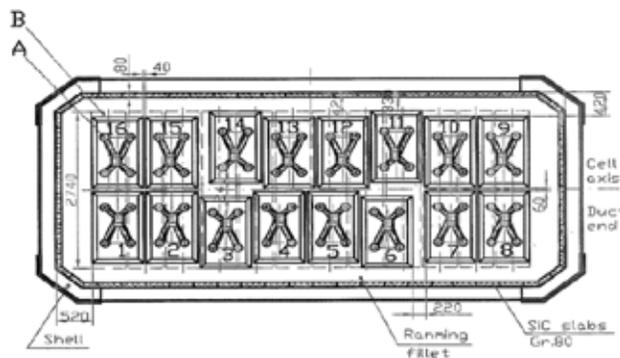
Fig. 3 below presents a simplified drawing of an electrolysis pot. Starting from the old pot design a modified design was developed to support the altered heat balance in order to replace the pots that failed before being able to test and establish the best design in the test section.

Fig. 3. Electrolysis pot simplified drawing: A: rodded anodes: 1250 x 750 x 620 mm; B: cathode blocks: 2740 x 500 x 450 mm

- increased cathode block length from 2400 to 2740 mm, in order to keep the same cathode current distribution;
- graphite content in cathode was increased to 30 %;
- decreased thickness of the sidewall in order to accommodate the longer cathode block;
- dimensions of the cathode bar were altered to be able to eliminate more heat through the cathode bar, to improve the contact between the bar and the block and to optimize cathode current distribution;
- shape of the cathode blocks center channel was also altered;
- shell plate thickness was doubled;
- a removable deckplate was applied in the top of the shell and the beams were reinforced in order to increase the shell resistance and minimize the shell bowing.

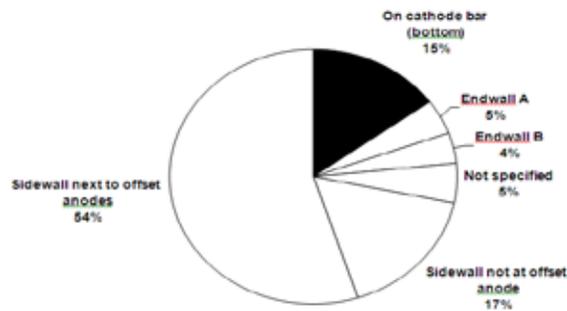
Fig. 4. Failure distribution at ALRO's pots with central feeding

Once the conversion to central feeding was finalized, the main mode of pot failure changed from failure on pot bottom to sidewall failure. Chart of failures distribution is shown in Fig. 4 below.

This type of failure (sidewall failure) would further be prevalent during the power amperage increase. Measurements of sidewall erosion in SiC slabs pots during autopsy coincides with statistical data, which indicated a higher failure, rate at the offset anodes 3 and 11.

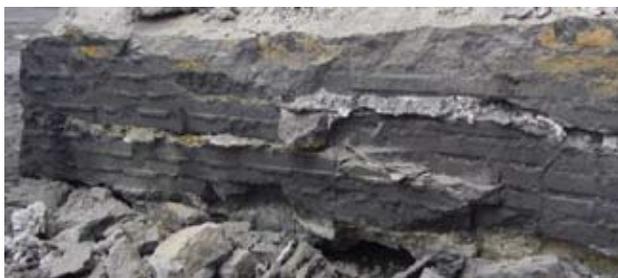
Fig. 5. Metal infiltrations in the horizontal cracks of a domestic cathode

The performed autopsies revealed that the cathode blocks produced in Romania, which consisted of 80 % gas calcined anthracite and 20 % graphite (GCA type), were prone to horizontal

cracking, as shown by Fig. 5, and would not withstand the 120 kA amperage. The purpose on the long term was for Alro to use high quality cathodes that were fully qualified in compliance with the aluminium industry standards. First step of the qualification process was to send the samples taken from the domestic cathode blocks to be analyzed by an international certified laboratory and to compare the results with the results achieved for other types of blocks from other producers.

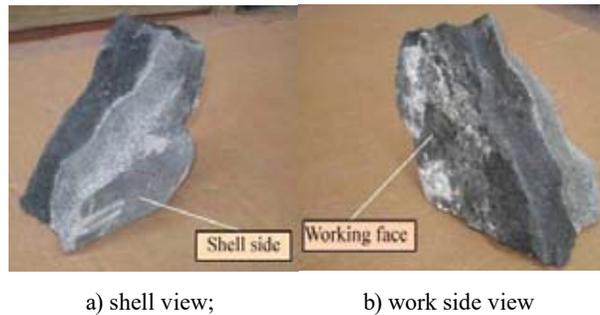
Fig. 6. Appearance of the sample

The recovered silicon carbide slab is shown in Fig. 6. The darker area with electrolyte deposit represents the inner work side and the opposite side slightly covered by grout represents the shell side.

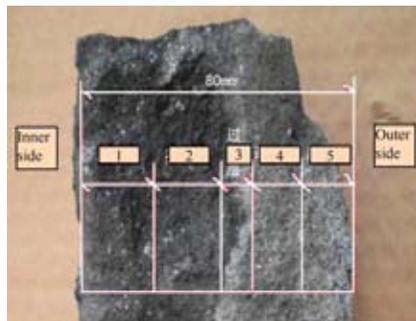
Fig. 7. Layer delimitation

The sample was split into 5 layers, as seen in Fig. 7, starting from the inner work side towards the outer shell side.

1. Black – pitch colour layer: section up to 20 mm from the work side;
2. Brilliant black colour layer: section between 20 – 40 mm from the work side;
3. Transition layer: section between 40 – 50 mm from the work side. This section appeared to be white and thin, connecting the inner black layers to the outer layers;
4. Loose layer: section between 50 – 65 mm from the work side. This section was loose and could be crushed by hand;
5. Original layer: section from 65 mm at the outer side, namely the area of up to 15 mm from the outer side. Visually, it generally continued to have the original shape/appearance.

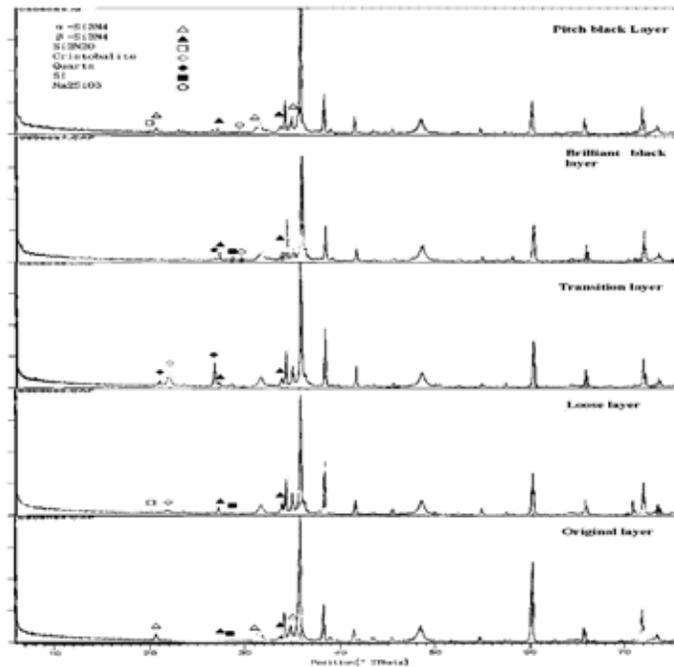
Fig. 8. XRD Spectrum of the 5 layers

The results are indicated in Fig. 8 which shows that SiC remains the main phase.

As shown by the XRD analysis result, α -Si₃N₄ exists in the slab only in the pitch black layer and in the original layer, and its content is lower in the pitch black layer than it is in the original layer.
