Analysis of defects of overhead facade systems and other light thin-walled structures

Abstract. This paper analyzes the defects and the causes of contemporary design solutions with an example of overhead facade systems with ventilated air gaps and light steel thin-walled structures on the basis of field experiments. The analysis is performed at all stages of work: design, manufacture, including quality, construction, and operation. Practical examples are given. The main causes of accidents and the accident rate prediction are looked upon and discussed.

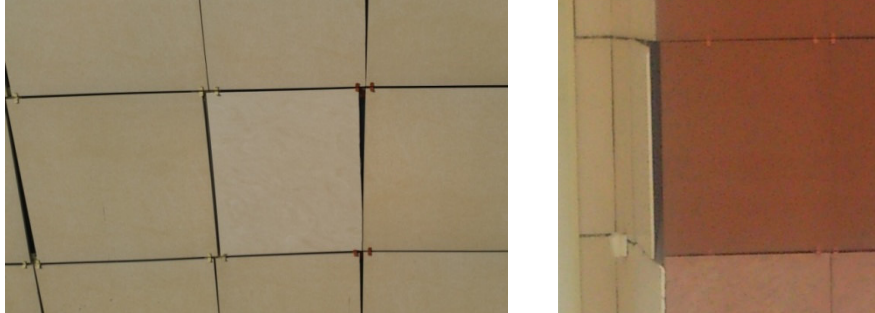
For example, the replacement of clasps from stainless steel by low carbon steel has led to the fact that some operation years later most of the façade elements have come out of its design position (Fig. 1), which has resulted in unrepresentable appearance of the building.

Fig.1. Defects of façade systems: facing walls design inconformity

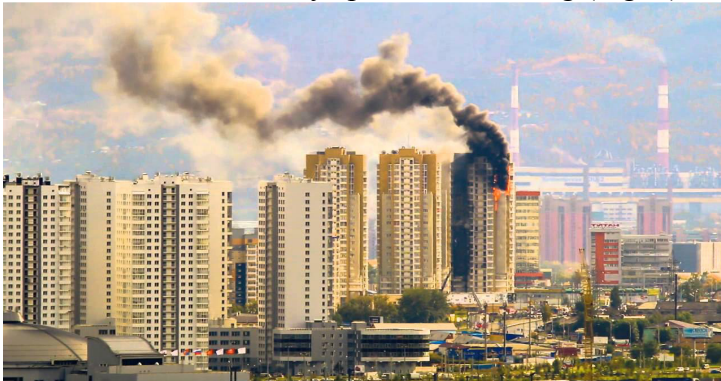
Replacement of composite cladding panels by a lower quality class of flammability led to the fire of the facade of a multistory apartment building (Fig. 2) in September 2014 in Krasnoyarsk (Russia).

Fig.2. A residential building is on fire in Krasnoyarsk (Russia)

In the researchers point of view the main causes of the façade system fires are the failure of fire prevention measures and savings in all phases of construction. Unscrupulous construction participants artificially create low cost structures design by eliminating unnecessary, from their point of view, trials, studies, calculations, installation of additional fire nicks, etc.

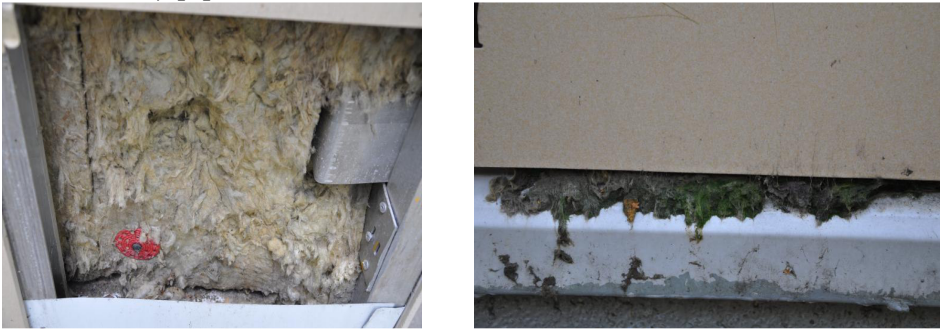
To eliminate fires the builders have recently started to refuse its use. The result is that the insulation is not protected from atmospheric influences, and after a while it begins to disintegrate into fibers, and this leads to the fact that the fibers clog the air gap between the insulation and the system facing material. Therefore, there is a violation of the functioning of the whole structure of the overhead facade system with a ventilated air gap (Fig. 4). But the gap is required for effective removal of moisture and vapors migrating from the premises through the outer wall to the street [6]. Its application is clearly stipulated in the design of a façade system, and the size is calculated depending on the main characteristics of the thermal protection enclosing structures (resistance to heat transfer) [7].

Fig.4. Result of hydro windproof membrane refusal

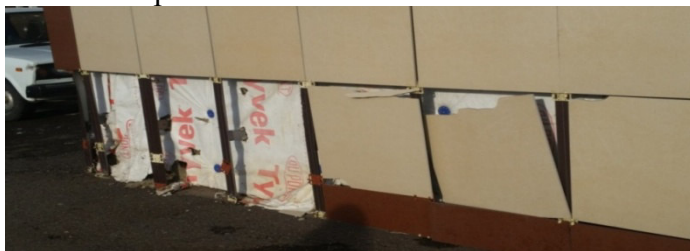
Fig. 5 shows defects in overhead wall systems, resulting from poor quality of the installation. The destruction of the cladding material occurs as a result of the fact that in the erection of the vertical profiles temperature joints have not been provided, moreover, they were concreted in the pavement around the building. As a consequence, thermal deformation of the profiles occurred, qualitative changes in the design of calculating schemes of bearing elements and the values of the loads acting on them took place.

Fig.5. Destruction of the cladding material

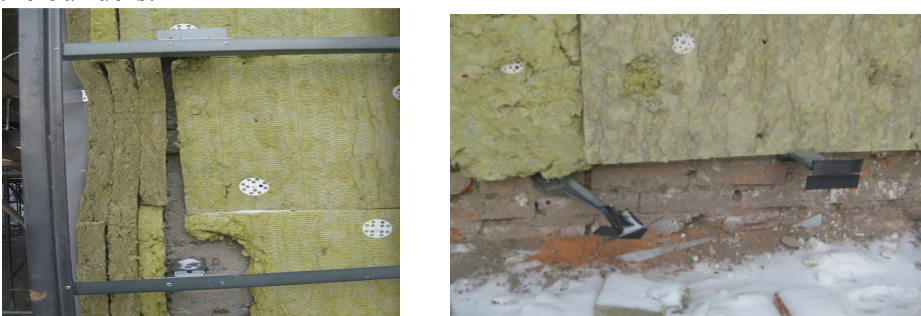
Fig. 6 shows the defects in the installation of overhead facade system caused by the negligence of the builders.

Fig.6. Defects in the process of overhead façade system installation
